MULTI-YEAR DYNAMICS OF THE CHANNEL PROCESSES IN THE DESNA RIVER NEAR CHERNIHIV CITY

Channel deformations of the Desna River near Chernihiv city were analyzed based on field studies and analysis of various temporal cartographic materials and space images. The hydrological regime of the river is characterized by intensive channel processes, which can be rather hazardous for the functioning of residential and economic infrastructure. Today, there is a rather worrying situation on the northeastern outskirts of Chernihiv city, where the channel meander is at the final stage of its development and in the period of the nearest high floods, the formation of a straightening duct and the transformation of the meander into a flood channel is possible. As a result, the river, which flows directly along the city outskirts and widely used for recreational purposes, will become several kilometers away from the city. Based on the study of the hydrological regime of the river, quantitative assessment of the morphological parameters of the river, and the nature and intensity of the transformation of the meander over a long period as well as the forecast of the development of the meander for the com

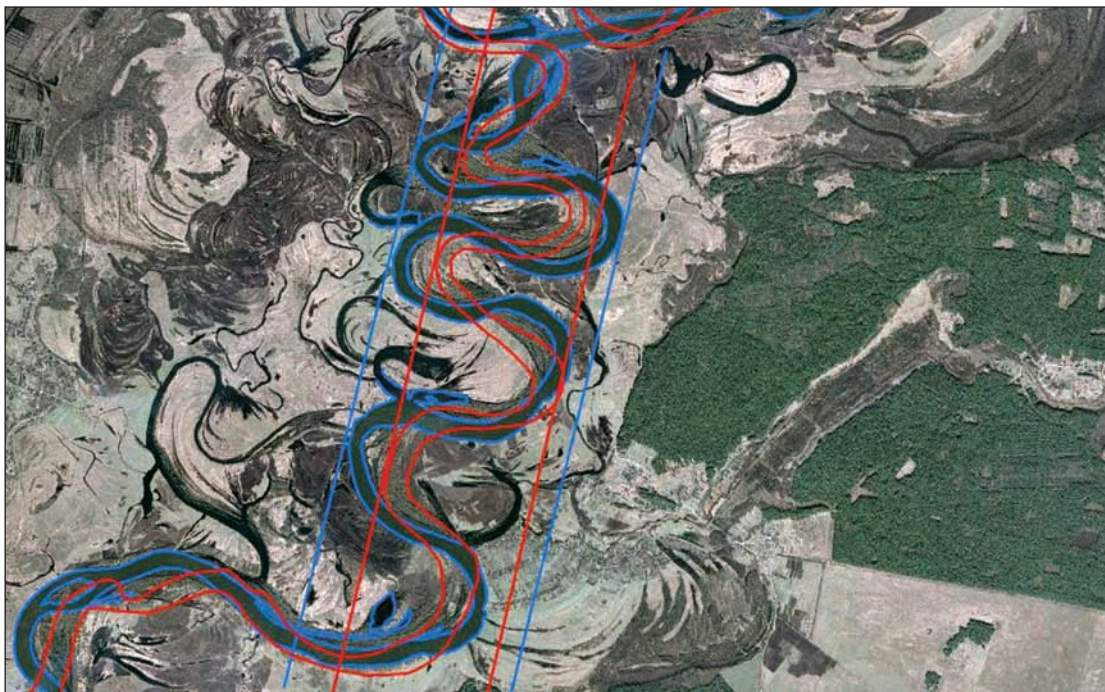
Fig. 1. Meandering section of the Desna River between the villages of Lebedivka and Nadynivka

Explanation to the figure: The red line is the contour of the meander as of 1943, the purple line is the contour of the meander as of 2021

incomplete meandering, characterized by full development of meanders on floodplains and incomplete cycles of forming straightening ducts. *Figure 1* shows a system of 7 meanders located on the 127–150 km section of the river. The two central meanders are developed by the classic scheme of free meandering. At the same time, the upper meander has already been broken long before the formation of the loop, and the 3 lower meanders are developing due to the erosion of the top of the meanders and the increase in the length of the channel. The width of the meander belt has increased from 1,685 m to 2,472 m since 1943, and the meander wave (the distance between adjacent knick points) remained constant. The erosion of the concave bank is more than 400 m, and the erosion intensity is more than 6 m/year. In the period of high floods, when the floodplain is inundated greatly, the formation of a straightening duct is possible in this area without forming a loop and breaching the land bridge.

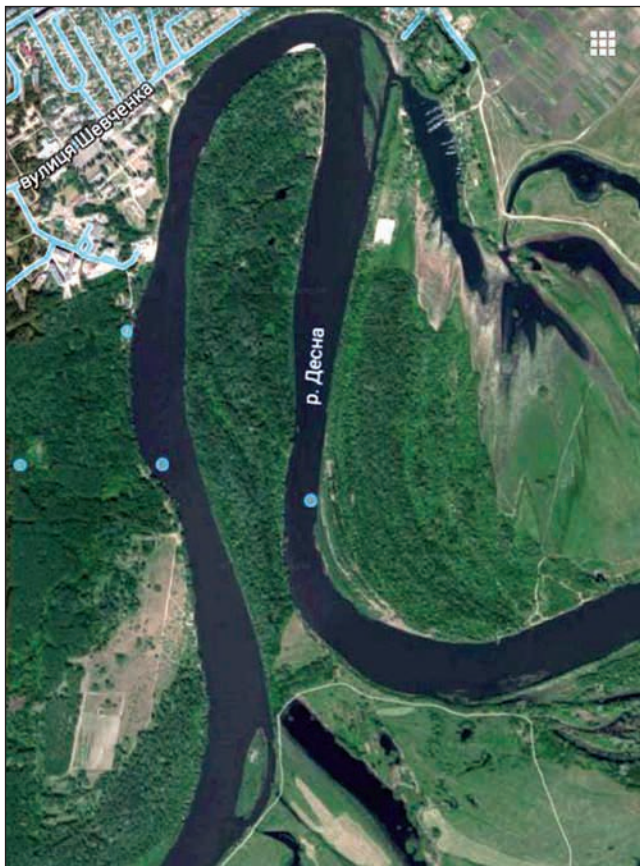
Fig. 2. Meander of the Desna River in the Bobrovytsia microdistrict of Chernihiv city

The meander in the area of the Bobrovytsia micro-district (*Fig. 2*) is at the final stage of its development. Its formation occurs due to the aggradation of the right bank at the meander mouth, erosion of the opposite left bank in the area of the land bridge, erosion of the left bank before the meander top, aggradation of the bank line water area near the opposite right bank (with the formation of an island), as well as the erosion of the meander top itself. That leads to its elongation and unfolding around a fixed point in the area of the knick point with the adjacent meander located downstream. Erosion occurs mainly during high floods, and aggradation occurs in low-water periods and during the flood decline. Similar but opposite processes are developing on adjacent meanders, the tops of which are oppositely directed. All this leads to constant erosion of the land bridge and will result in its inevitable breaching in the future.

the width of the meandering belt is about 3 km, the width of the land bridge in the narrowest place is only 155 m, the width of the meander in the middle part is 140 m. Erosion of the left bank and aggradation on the right bank of the upper wing of the meander and aggradation of the left bank and erosion of the right bank on the lower wing of meander create the effect of the meander sliding downstream.

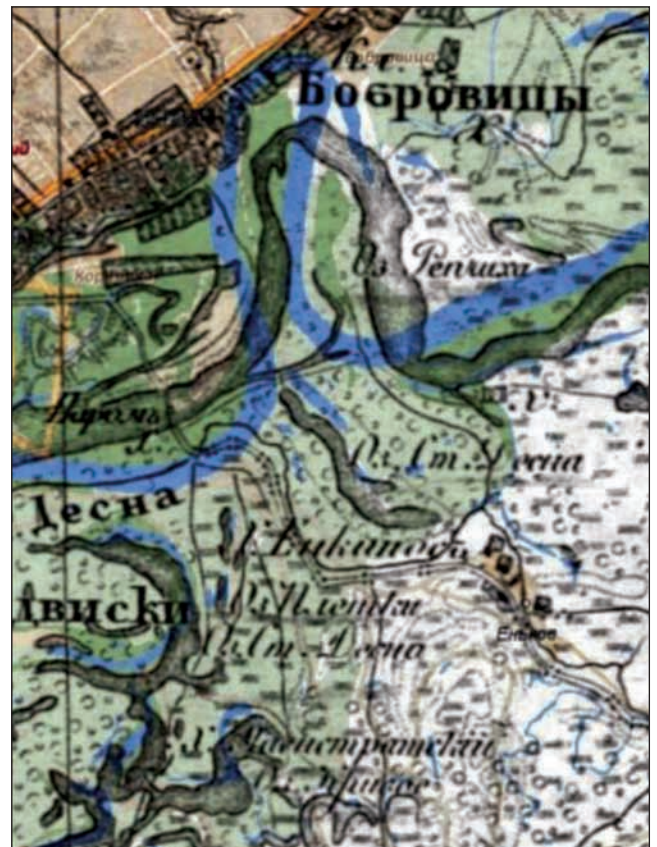
Fig. 3. Combined 19th-century and modern topographic maps of the studied area (modern contours of the meander are shown in blue)

The dynamics of the meander development over the past century and a half can be traced based on a comparative analysis of topographic maps and space images. Fig. 3 shows combined maps of the meander section — a map of the second half of the 19th century and a modern topographic map. Fig. 4 shows a military topographic map of 1941, a map of the General Staff of 1989, and a modern space image. In the presented images, we can see the transformation of the meander shape from sinusoidal (almost symmetrical regular shape) with a wide land bridge to an elongated, extended, and loop-like one with a narrow land bridge.

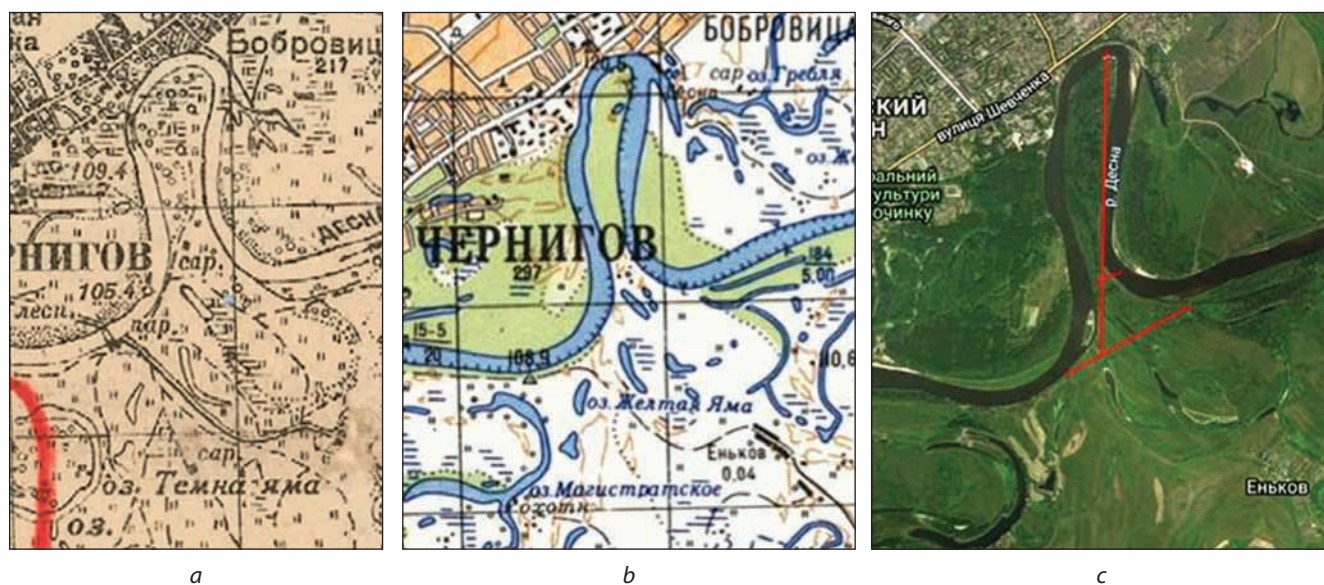
Fig. 4. Topographic maps of 1941 (a), 1989 (b) and a modern space image (c)

maximum depth of the channel is 5 m. Downstream the land bridge the talweg moves away from the bank by a distance of 25 m, and its depth increases to 6 m (Fig. 4). In general, the analysis of bathymorphic studies in the section of land bridge indicates intensive accumulative processes near the convex right bank and the shift of the river talweg towards the curved left bank in the section of land bridge. That, in turn, indicates a high probability of shifting the talweg directly to the left bank in case of intensive floods, which will inevi-

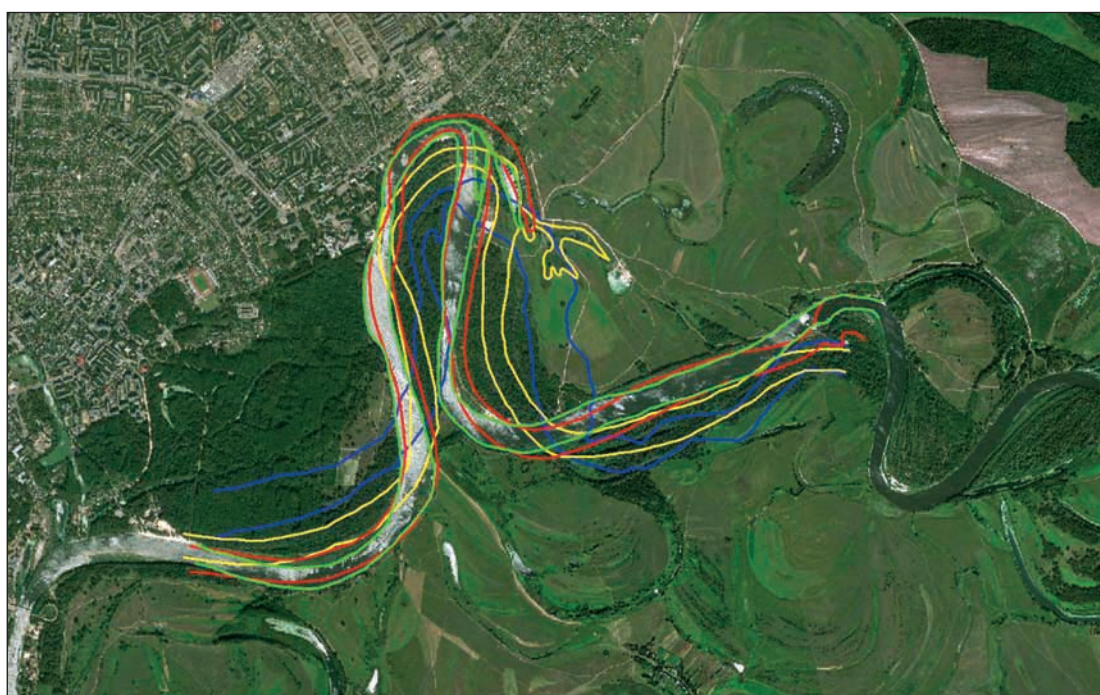
Fig. 5. Combined meander contours since 1868 (blue line — contours of 1868; yellow — 1941; red — 1989; green — 2018)

Presented in Fig. 5, the combined contours of the meander for the period since 1868 demonstrate the intensity and nature of changes in the parameters of the meander top and its position. Intensive development of channel processes and the meander mainly occurs during high floods. Since 1970, high floods have not occurred on the Desna River, but despite this, the meander continues to develop even now. Fig. 7 and 8 show the dynamics of the development of the meander top for the period from 2007 to 2012 and 2018. Pictures taken only in the low-water period, where there

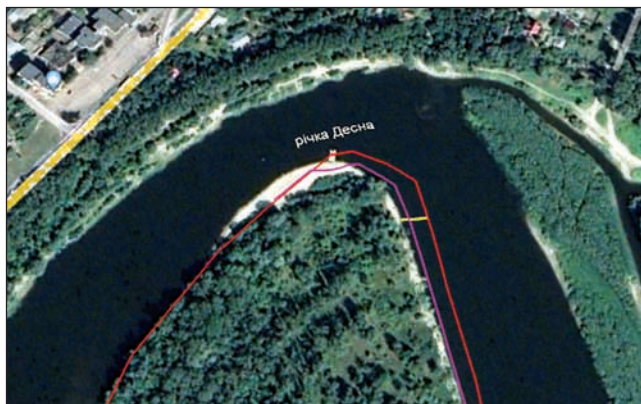
Fig. 7. Space image of the convex bank of the meander top as of July 24, 2018 ($H=103.98$ m BES)

Explanation to the figure: The red line is the contour of the meander top as of July 27, 2007 ($H=104.19$ m BES); the purple line is the contour of the meander top as of October 3, 2012 ($H=103.88$ m BES); yellow line is erosion width for 2007–2018.

were low water levels, were used to ensure the reliability of the assessment. In 2007, the level was 31 cm higher than in 2012 and 21 cm higher than in 2018. Analysis of the figures shows that the width of erosion of the left meander bank before its top for the first five years was 16 m, and in subsequent years, it increased to 26 m (yellow line in *Fig. 7*). The erosion area before the meander top is shown in *Fig. 9*.

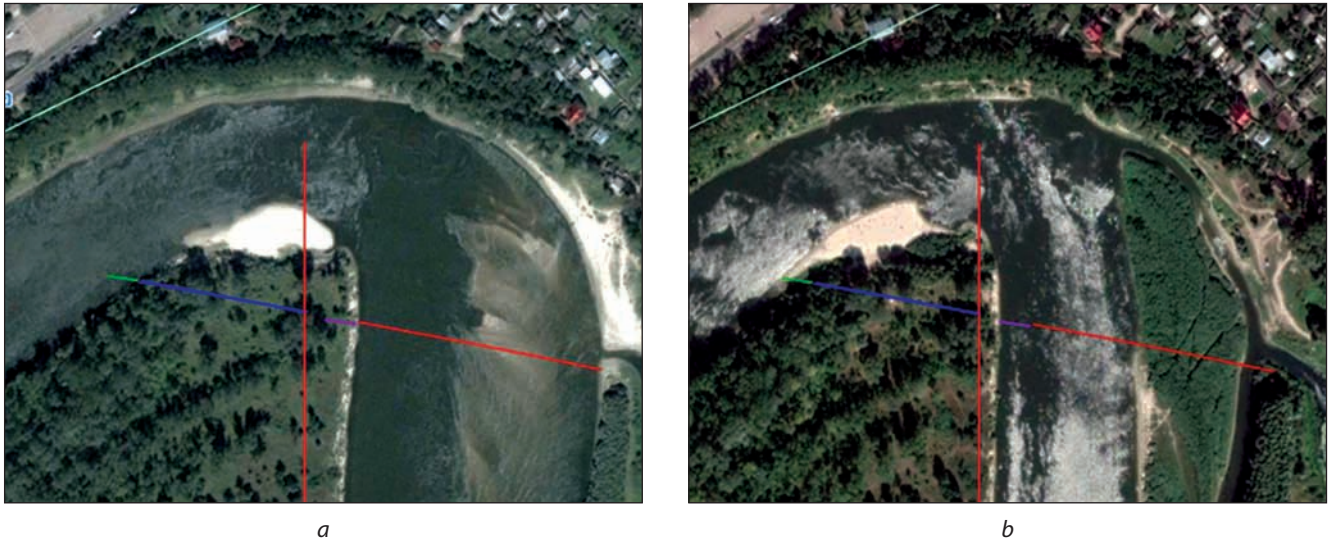
Fig. 8. Satellite images of the meander section in 2007 (a) and 2017 (b).

Explanation to the figure: The horizontal red line is the channel width in 2007; the purple line is erosion of the left bank before the meander top; the green line is left bank aggradation behind the meander top; (to compare the dynamics of the meander since 1985, a vertical red line was drawn from the right bank of the top of the meander in 1985)

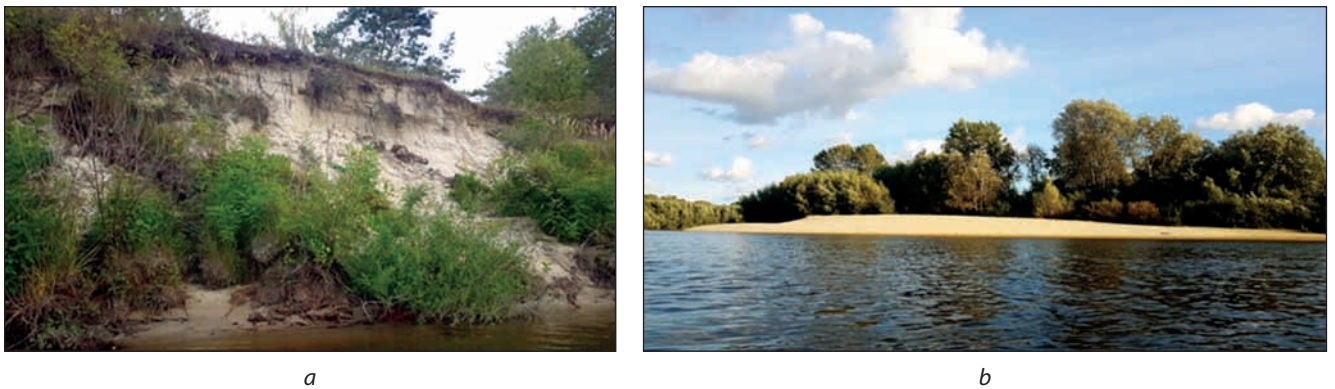
Fig. 9. Erosion of the left bank before the meander top and aggradation behind the meander top

Simultaneously with the erosion of the left bank before the meander top, the sand spit aggradation occurred behind it (*Fig. 9*) with a width of about 10 m. The specified erosion is primarily caused by relatively high flood flow rates during floods in 2010 ($843 \text{ m}^3/\text{s}$) and 2012 ($710 \text{ m}^3/\text{s}$). The slip of the meander top can be seen in *Fig. 10*, where a red line with fixed coord-

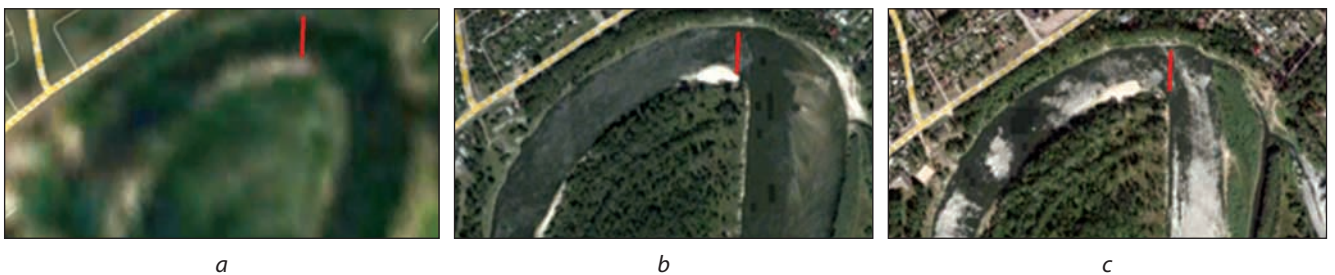
Fig. 10. Slipping the meander top: a — 1985; b — 2007; c — 2017

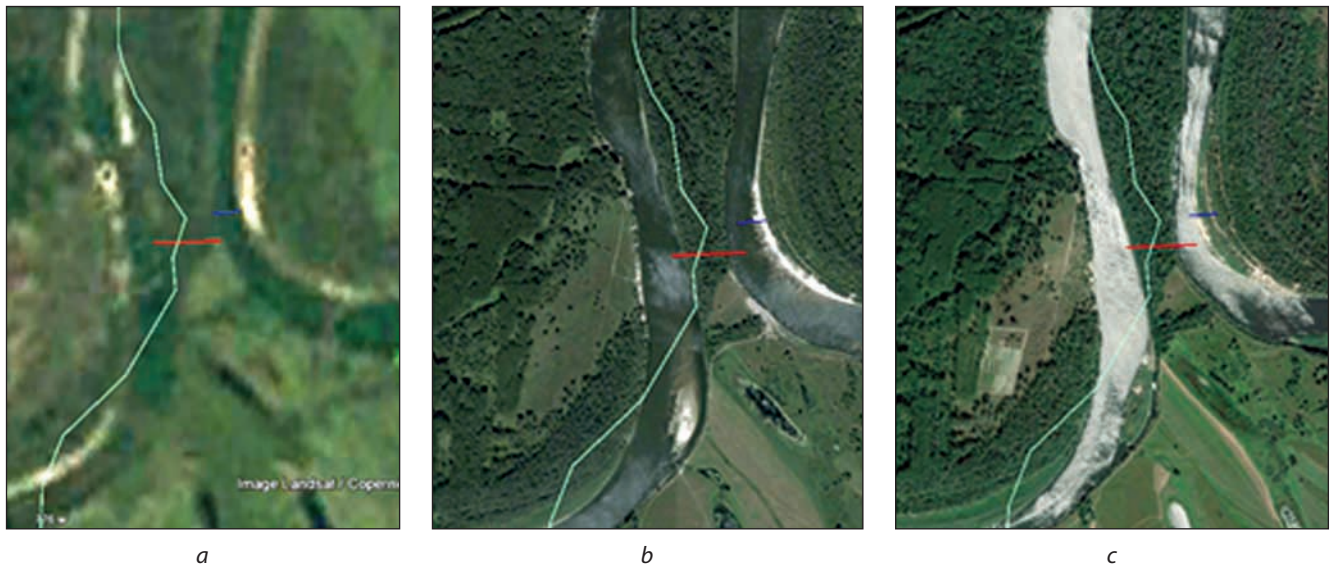
Fig. 11. Erosion of the meander land bridge from 1984 to 2017: *a* — 1984; *b* — 2007; *c* — 2017

Explanation to the figure: The red line is the width of the land bridge in 1984; the blue line is the aggradation of the opposite to the land bridge, right bank.

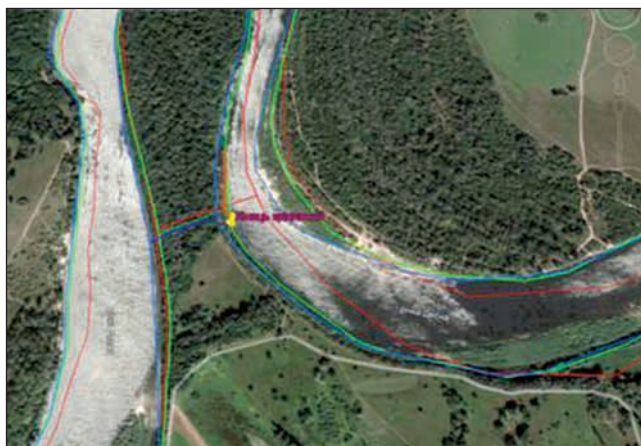
Fig. 12. Combined contours of the left bank of the meander in the section of the land bridge

Explanation to the figure: red line — 1985; green line — 2007; blue line — 2020. The thick brown line indicates the required length of the bank protection.

processes are observed. The bank here is sandy, steep, almost vertical, and strongly eroded, with a height of about 5 m. Intensive bank erosion is largely restrained by the well-developed root system of trees and shrubs (Fig. 16). To prevent further erosion of the bank and a possible breaching of the land bridge during intensive floods, it is necessary to extend the bank protection along the entire length of the left bank of the meander in the section of the land bridge, i.e. for a distance of about 200 m. The area of the necessary bank protection is shown in Fig. 12.

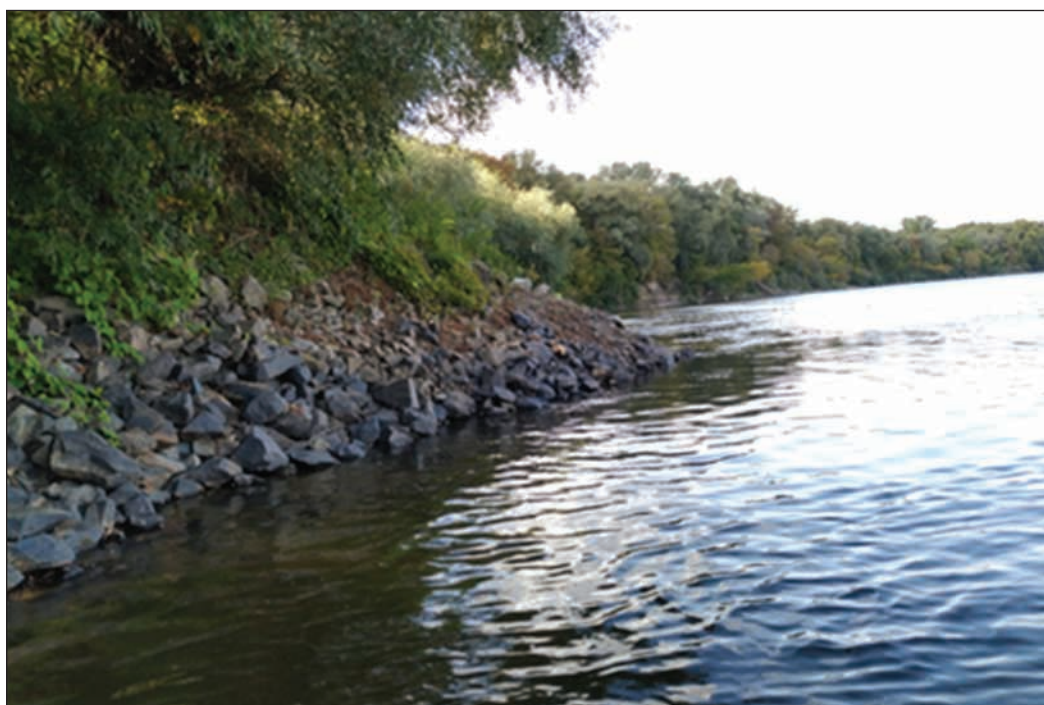
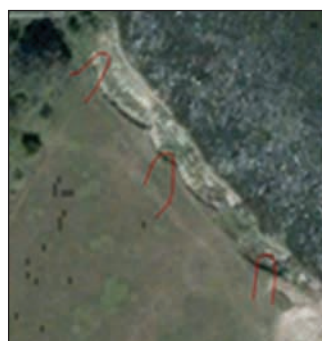
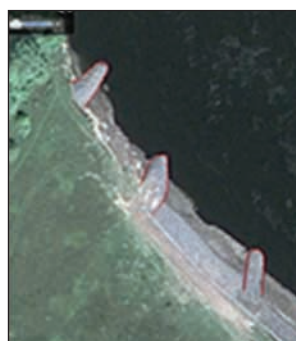
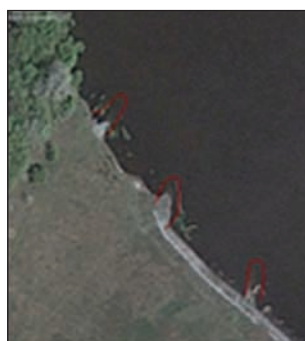
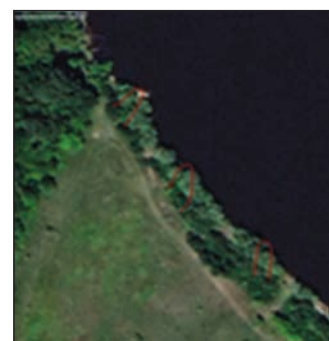
Fig. 13. Bank protection on the land bridge of the meander (red lines show the initial contours of the spur dikes, as of 2009)

short bank protection spur dikes were also arranged to prevent the land bridge erosion (Fig. 13). That made it possible to stabilize the bank line and prevent the breaching of the land bridge. As the space images show, the bank protection structure was built in 2008 (in the 2007 image (Fig. 13 b), it was not yet there). By

2012, the spur dikes were partially destroyed (Fig. 13 c), but by that time they had already fulfilled their function, provided bank protection. Today, the spur dikes have been almost destroyed, and only the lower one is partially saved (Fig. 13d). The condition of the bank protection structure is satisfactory today, but its length

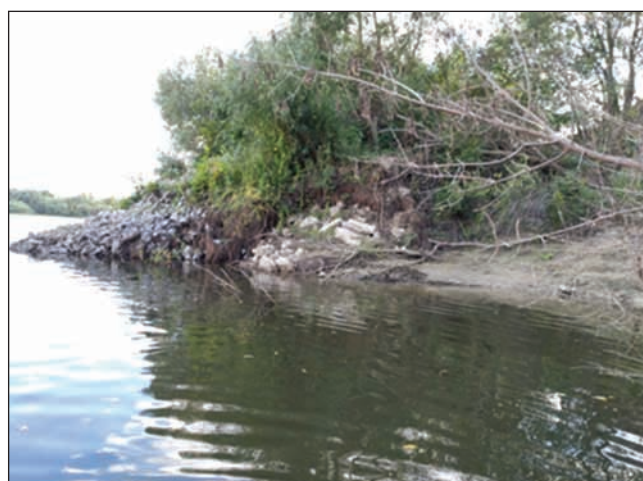
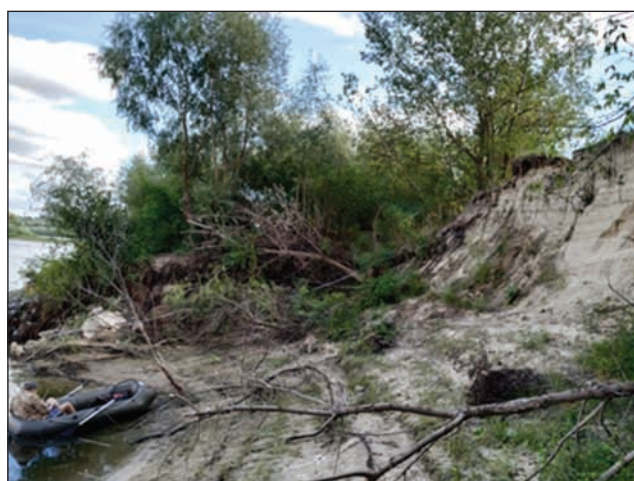
Fig. 14. Erosion of the bank beyond the bank protection zone

The width of the bank erosion after the bank protection structure is 13 m (Fig. 14). After the section of stone facing, the bank was partially reinforced with concrete slabs, but they were destroyed and do not perform a protective function today (Fig. 15). Stabilization of the land bridge section as a result of the completed bank protection, as well as the bank erosion downstream of the bank protection structure, caused the displacement of the land bridge. Today, its narrowest point is not at the meander mouth but downstream, where the most intensive bank erosion

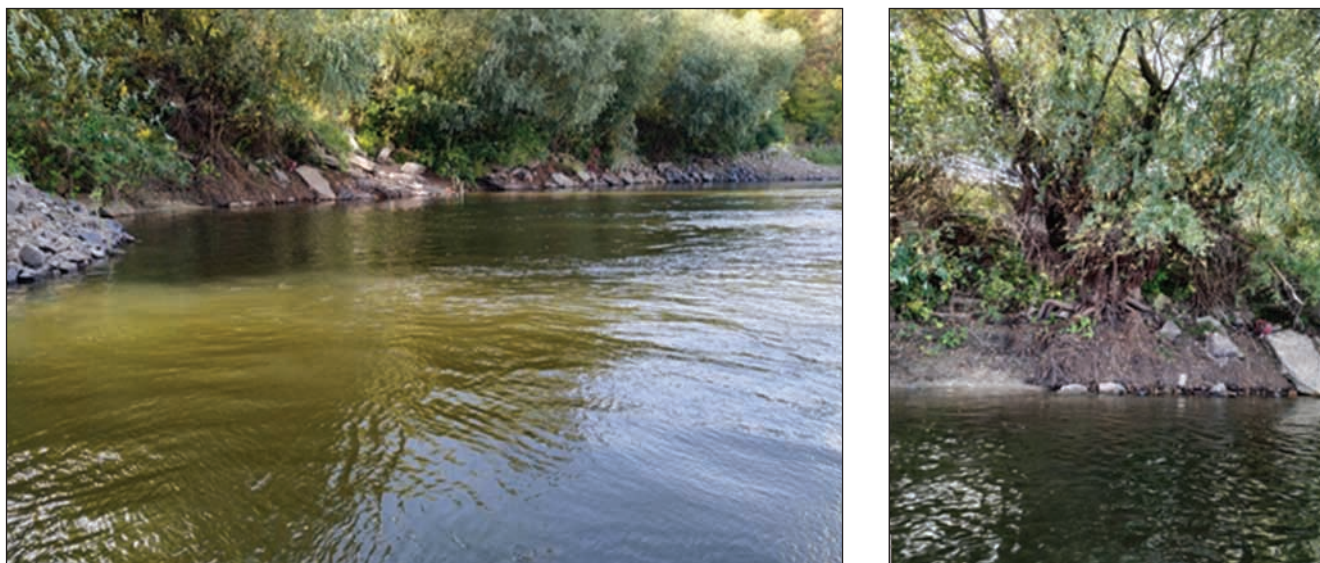
Fig. 15. Remains of bank protection with concrete slabs downstream the area of the stone facing

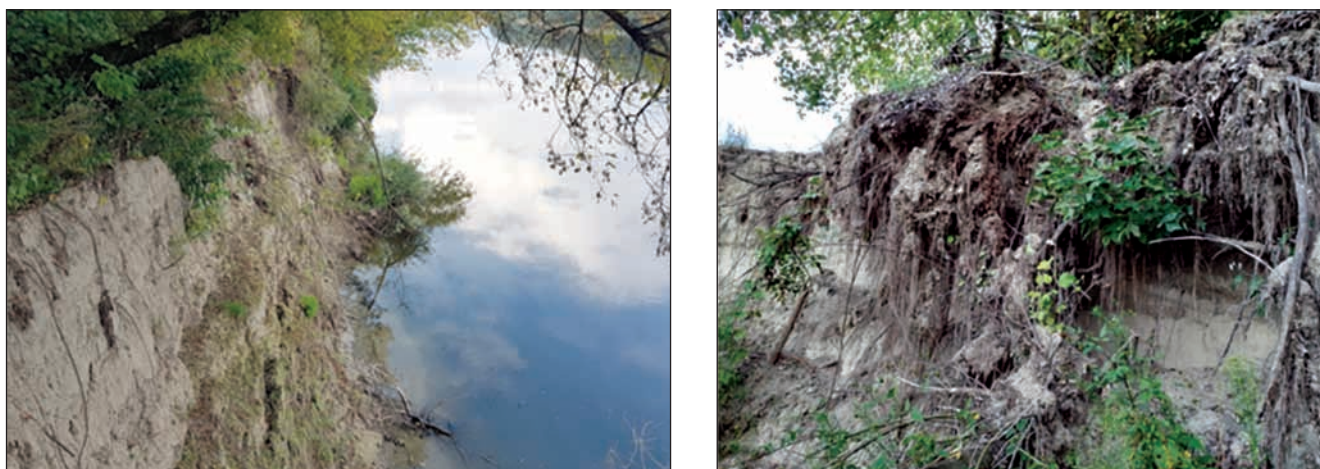
Fig. 16. Erosion of the land bridge downstream the bank protection area

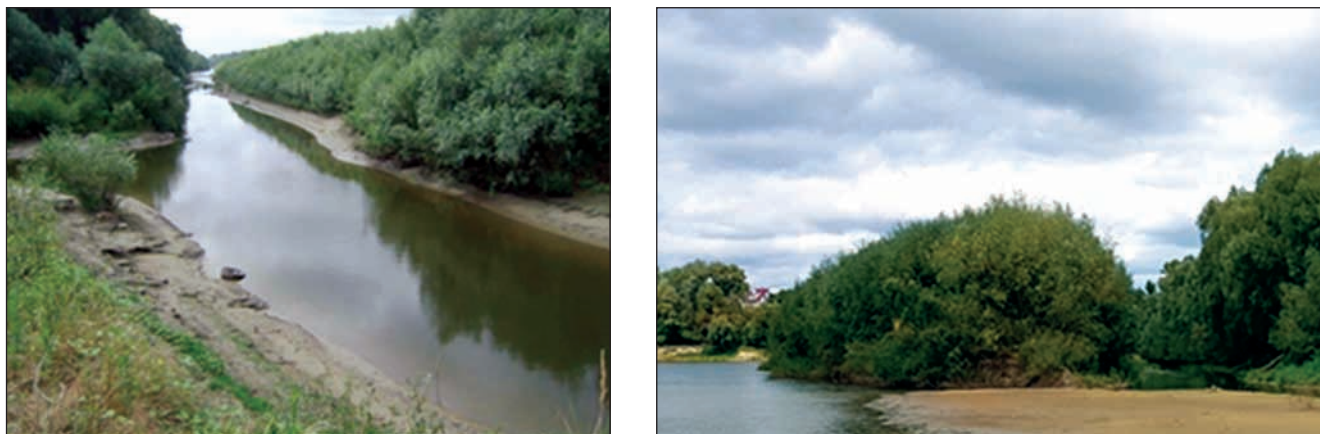
Fig. 17. Channel between the island in the meander section: *a* — upstream; *b* — downstream

As a result of the intensive deposition of sediments just before the meander top near the right bank, a sandbank with an overwater part almost 90 m wide (in the low-water period) was formed, which, as a result of the formation of a shallow channel (Fig. 17), turned into a sandy island (Fig. 18), at present overgrown with shrubs more than 2 meters high.

As a result of a sharp decrease in the channel cross-section there is a sharp increase in the speed of the stream flow, which, in turn, activates the erosion processes of the left bank and the accumulation of sediments in the middle part of the channel and along the right bank (Fig. 17b, Fig. 24), aggradation of the left bank near the meander top, as well as intensification of erosion of the right bank (from the city side) in the section of the meander top.

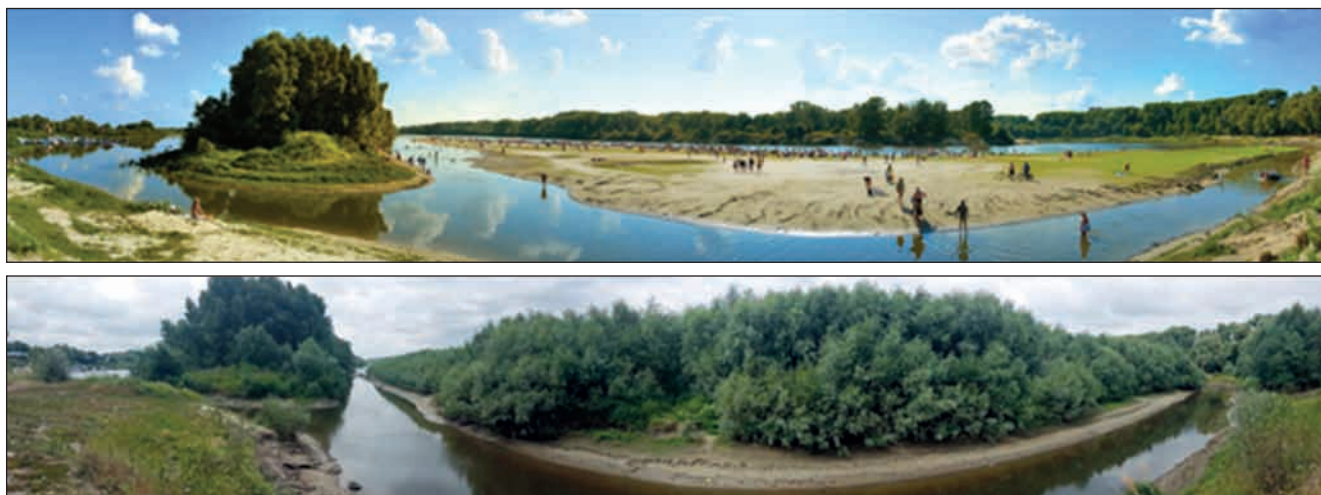
Fig. 18. Panorama of the island from the side of the boat station as of 2015 (a) and 2019 (b)

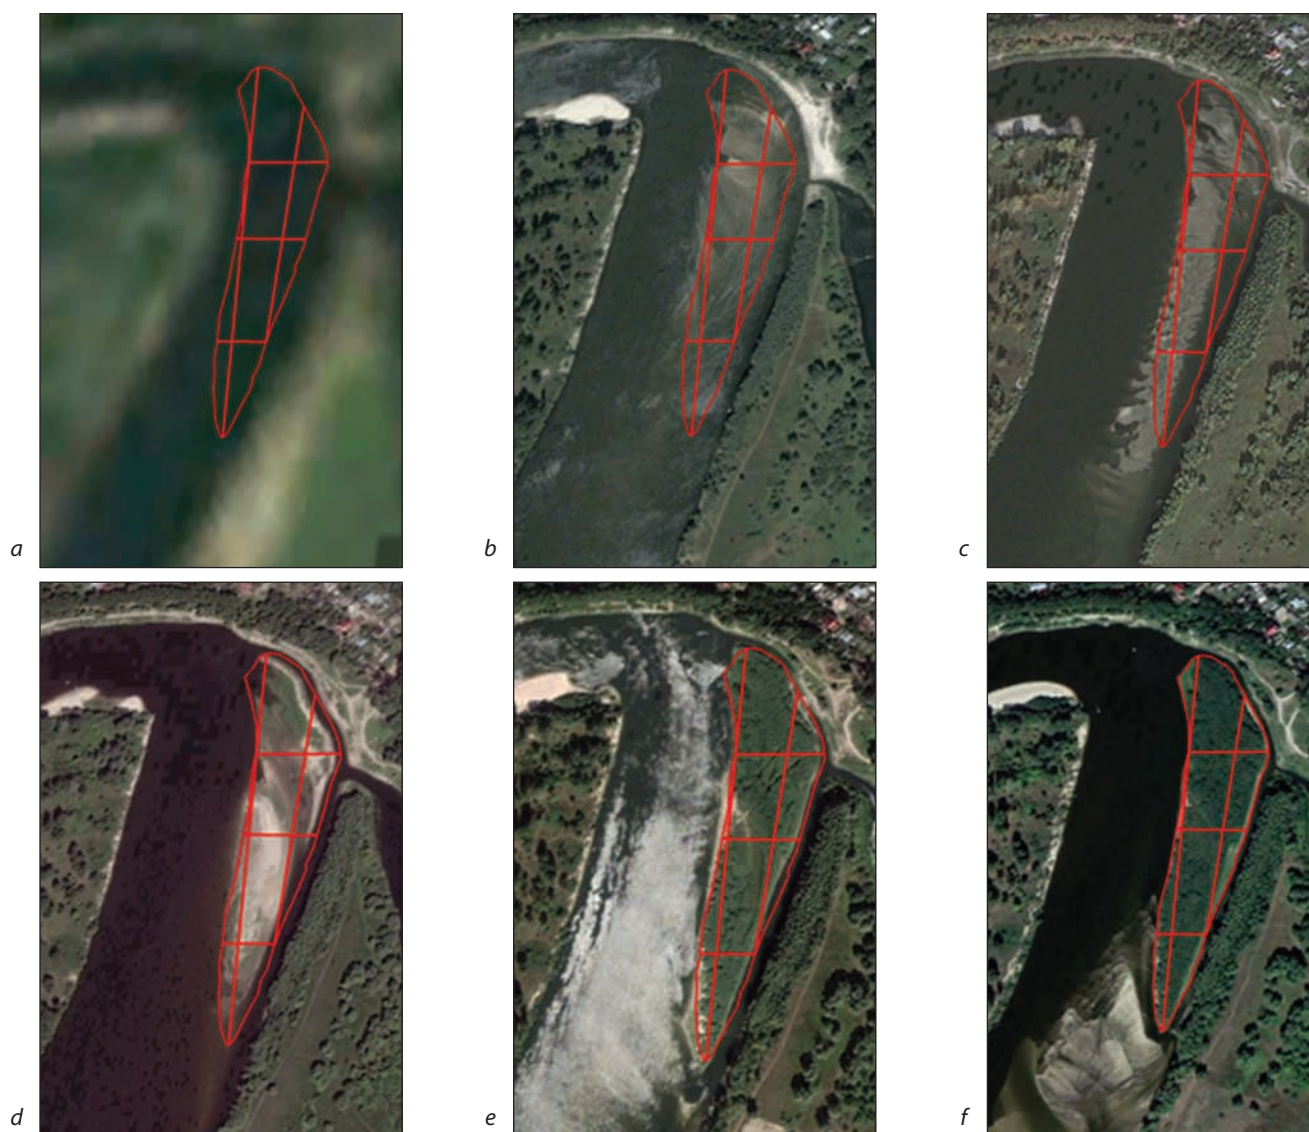
Fig. 19. Dynamics of island formation before the meander top: a — 31.12.1985; b — 27.07.2007, $H=104.19$ m BES; c — 03.10.2012, $H=103.84$ m BES; d — 08.06.2015, $H=104.22$ m BES; e — 20.08.2017, $H=103.70$ m BES; f — 19.08.2019

In Fig. 19, space images of the island are given in chronological order, on which the contours and parameters of the island in the low-water period of 2019 are drawn with red lines, which enables us to assess the intensity and mechanism of its formation. For analysis, only the pictures taken in the low-water period were selected. The maximum amplitude of the water level in the given pictures is 52 cm. The height of the island above the low-water level in September 2021 (103.37 m above sea level) was 2.08 m. The transverse profile of the left bank of the island in its middle part and the survey area are presented in Fig. 20. In 1985, the island did not exist yet, and the meander top (convex left bank) was only 26 m away from the current position of

height of the island has been taking place since 2014 (Fig. 19d).

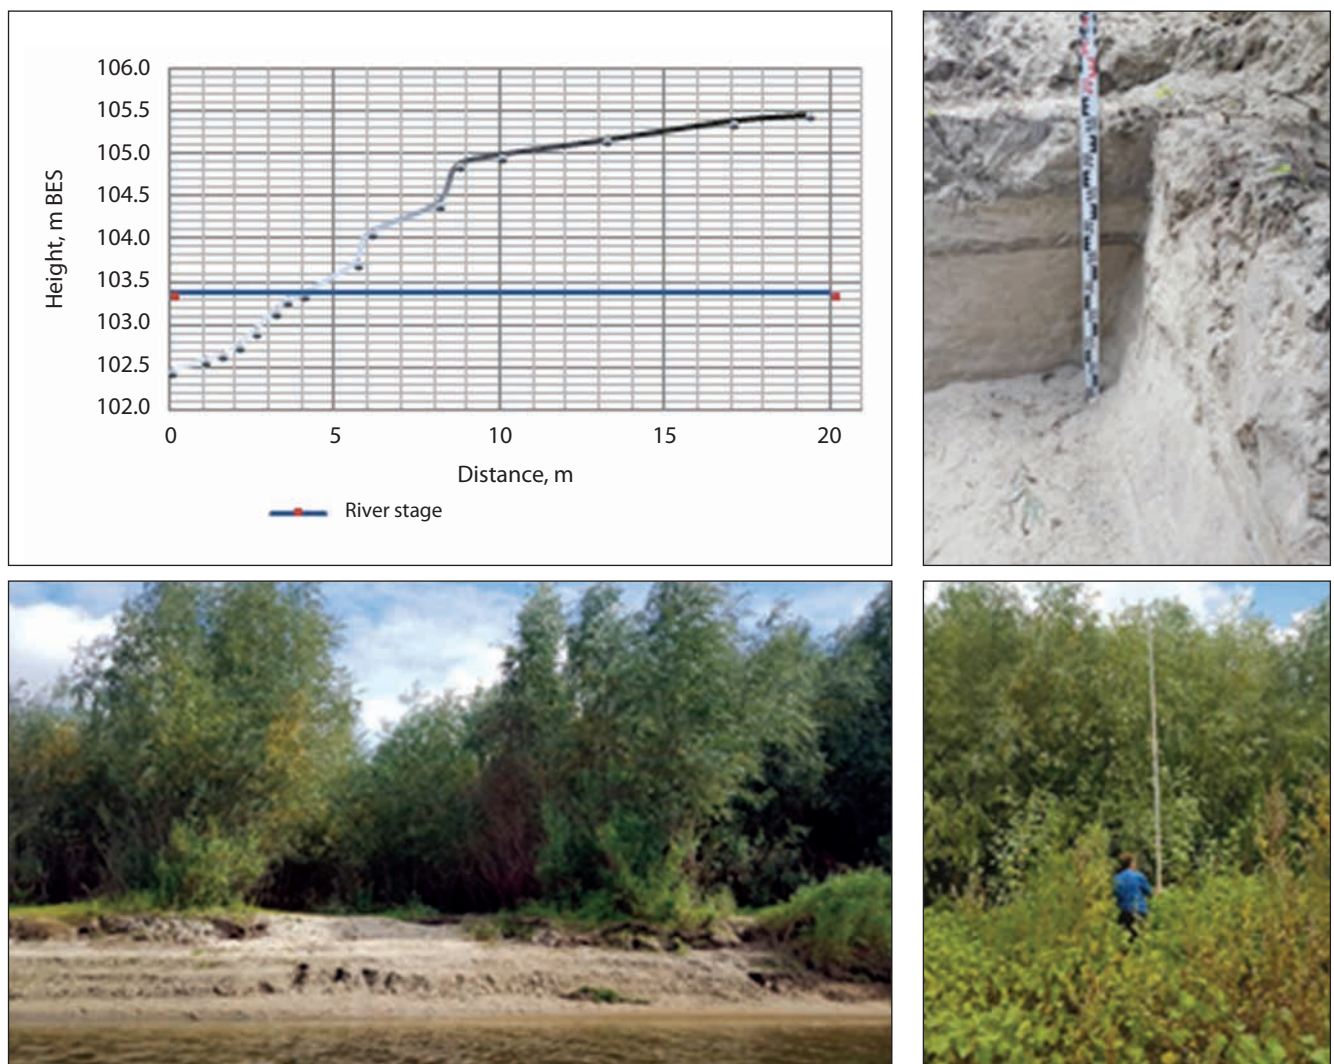
Fig. 20. Transverse profile of the island bank and cross section

of the island in September 2021 was 105.45 m above sea level, and the height of shrubs and trees on the island reached 3–5 m (Fig. 20). Fig. 21a–c show space images of the island during the floods of 2011, 2016, and 2013, when the water levels were 0.26 m, 1.4 m, and 3.39 m, respectively, and higher than today's levels of the island surface. The contours of the island cannot be traced not only during the high flood in 2013 (only the tops of tall trees on the right bank and in the area of the boat station are visible (Fig. 21c)) but also during the low floods in 2011 and 2016 (Fig. 21a, b), which indicates the absence of tree vegetation on the island in those years. That is also confirmed by a panoramic photo of the island taken in 2015 (Fig. 18a) at the canal outlet from the boat station. As can be seen from the picture, the island was not high; its height above the low-water level visually did not exceed 1 m. The absence of tree vegetation on the island in the photos indicates that the intensive increase in the

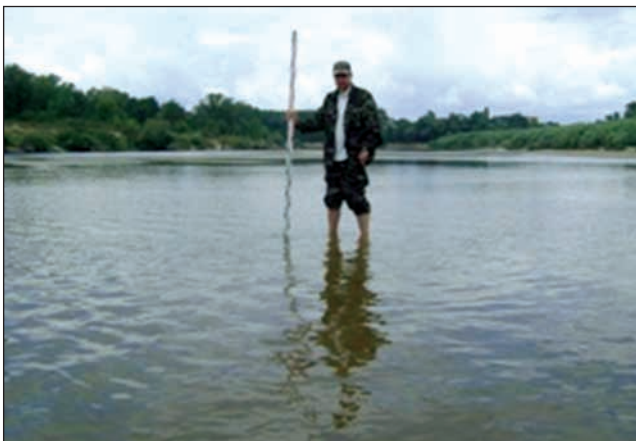
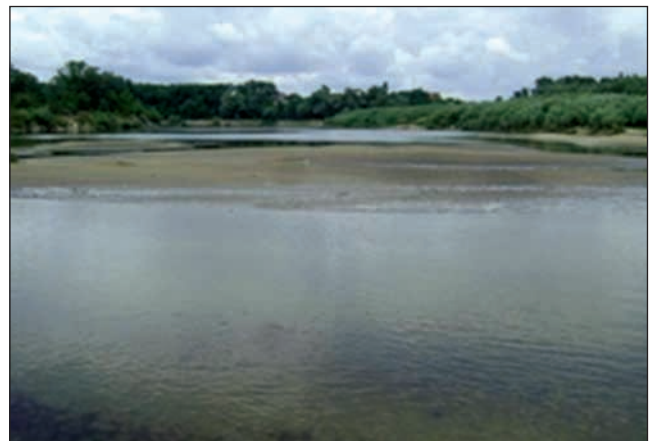
Fig. 22. Sandbanks on the Desna River within the boat station

the channel, the depths were 10–40 cm (Fig. 22). Along the upper wing of the meander, the flow is pressed against the left bank and the talweg is at a distance of 15–20 m from the low-water mark, which caused intensive erosion of the left bank (Fig. 23). In the section of the middle of the island, the fairway channel gradually moves to a distance of 70 m from the bank.

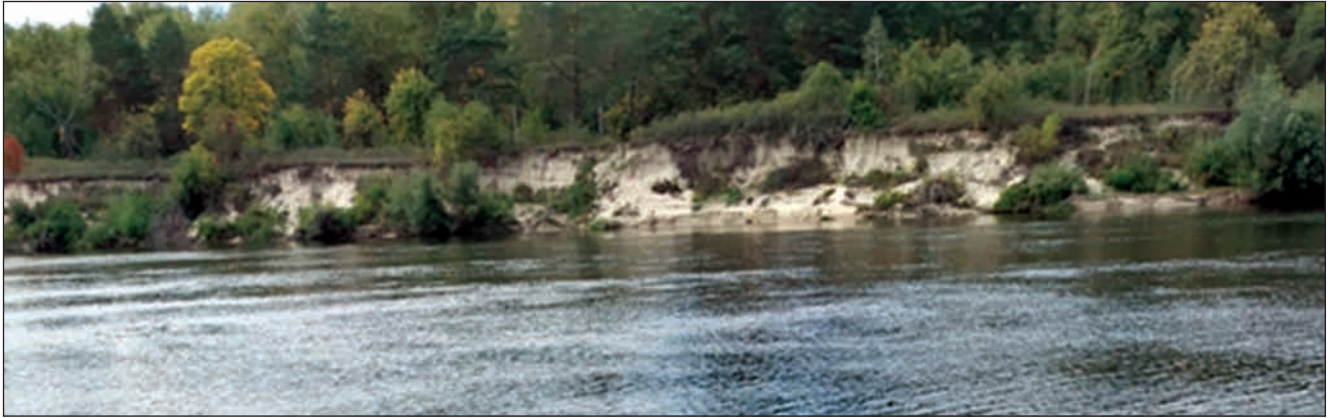
Fig. 23. Erosion of the left bank of the Desna River to the top of the meander

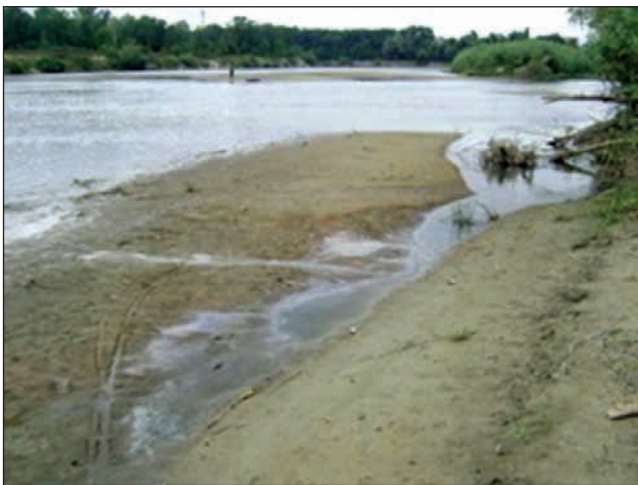
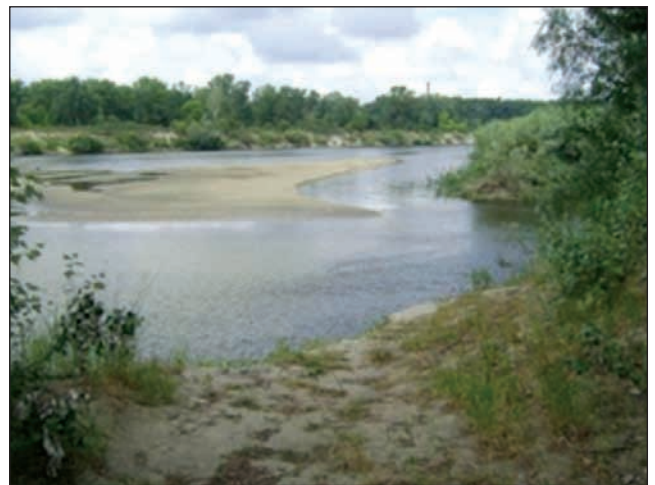
Fig. 24. Sand aggradation before the island

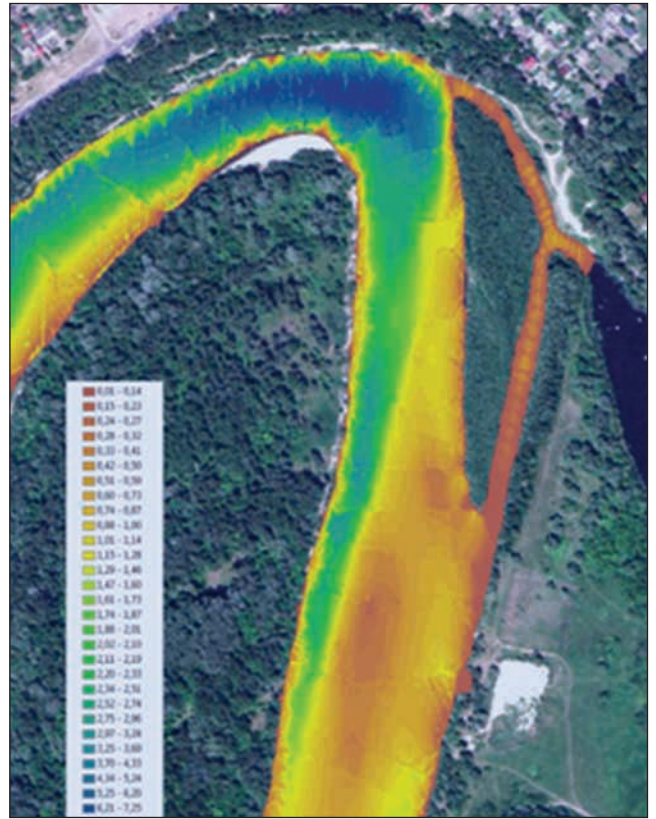
Fig. 25. Maps of depth measurements (m) at the meander top on the Desna River: a — 11.07.2019; b — 13.09.2021

Determination of the bathymetric parameters of the meander and assessment of the channel dynamics in recent years were performed based on bathygraphic studies on July 11, 2019, and September 13–15, 2021. The water level during the study in 2021 was 103.37 m BES, which is only 2 cm higher than in 2019. That enabled us to perform a comparative assessment of depths and vertical channel deformations without making corrections for different water levels. The measurement results are given in *Fig. 25*, where stream flow depths are shown using the appropriate depth scale. The scheme of gauging sections is shown

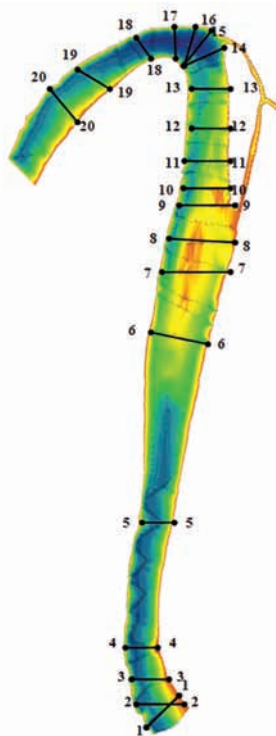
Fig. 26. Gauging sections of the upper wing of the meander on the Desna River

in *Fig. 26*. It should be noted that the last two years were characterized by very low water content, low transport capacity of the river, and minimal channel deformations and sediment flow. Channel processes were mainly characterized by only slight transformation of bottom sediments and silt deposition.

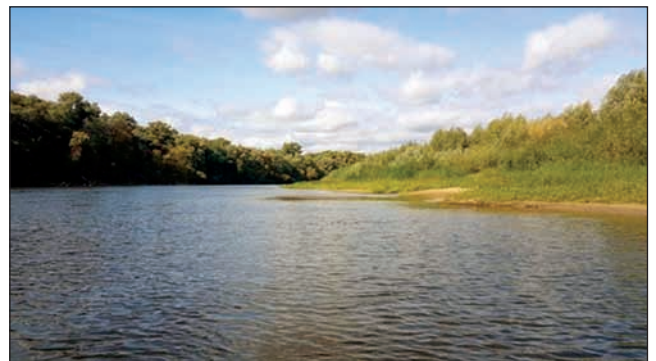
Fig. 27. Accumulative processes along the right bank at the beginning of the meander (section of the land bridge)

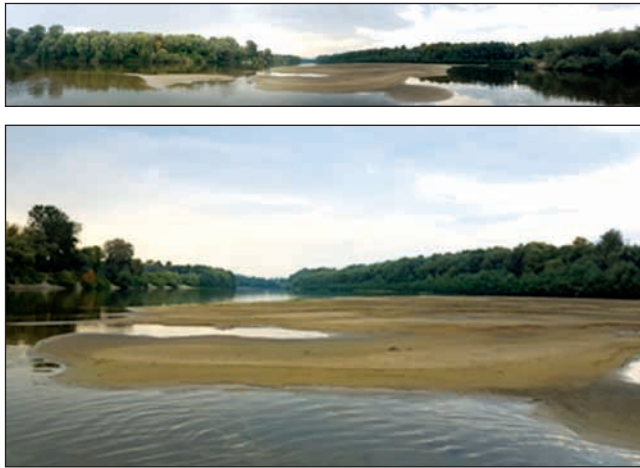
Fig. 28. Island in the middle part of the channel

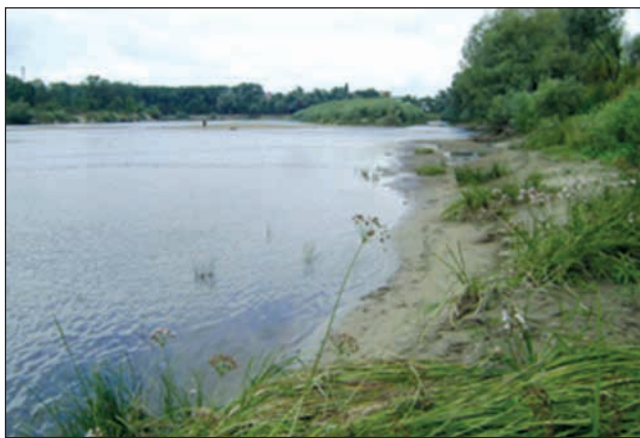
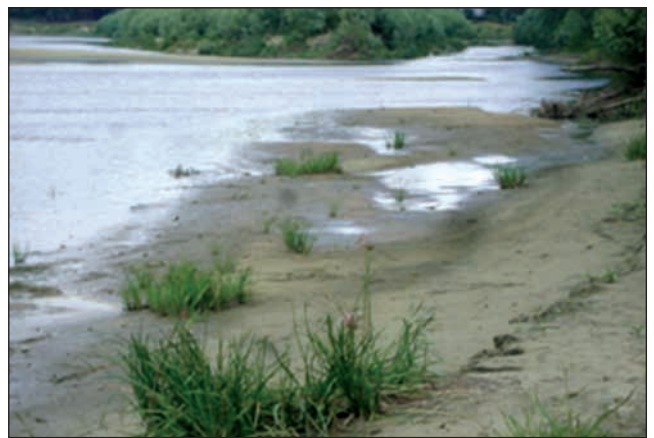
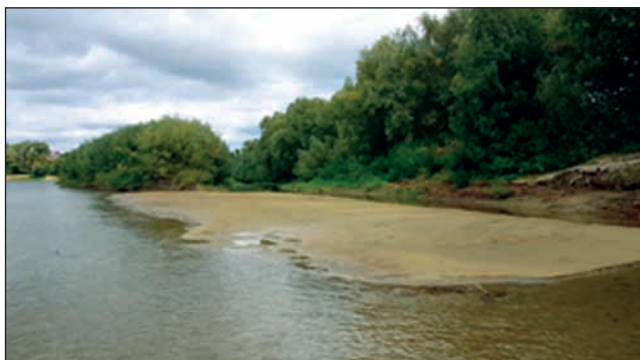
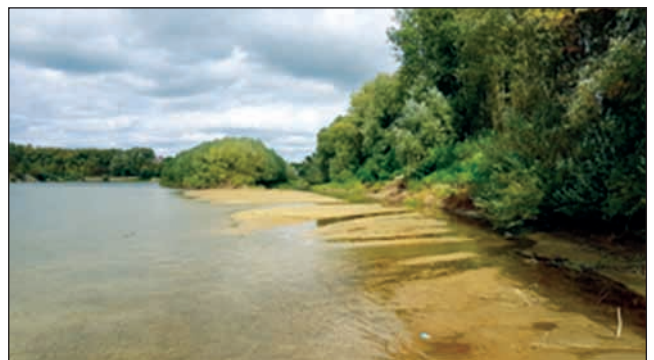
Fig. 29. Sediment accumulation before the island: *a, b* — 2019; *c, d* — 2021

Downstream, the width of the channel increased to 190 m in the distance of 350 m from the beginning of the island, and the main channel began to form near the left bank, with a depth of 2 m, as a result of that the height of the island increases. If in gauging cross-section 6 the depth in the central part of the channel was 0.6 m, then in gauging cross-section 7 it decreased to 0.2 m, i.e. it was aggraded by 40 cm. Downstream the underwater island appeared above the water surface (Fig. 28). Over the past 2 years, there was a significant accumulation of sediments near the right bank directly before the island. Aggraded sandbanks appear above the water's surface, blocking the canal near the island. If only an underwater side head was observed directly before the island and the canal in 2019 (Fig. 29a, b), then in 2021, accumulative depo-

sits were visible above the water surface (Fig. 29c, d). The right-hand channel was filled with sand. The talweg of the channel shifts to a distance of 12 m from the left bank, and the maximum depth of the channel increases to 2.4 m (gauging cross-section 8).
